SMALL STEEL PROJECTILE FIRINGS AGAINST SIMULATED
REINFORCED CONCRETE SLAB. (U) NAVAL WEAPONS CENTER
CHINA LAKE CA J C SCHULZ ET AL. JAN 84 NWC-TP-6501
SBI-AD-E900 320

4. TITLE (and Subtitle) SMALL STEEL PROJECTILE FIRINGS AGAINST SIMULATED REINFORCED CONCRETE SLABS AT NORMAL INCIDENCE AND OBLIQUITY		5. TYPE OF REPORT & PERIOD COVERED Research Report FY 1982-1983

6. PERFORMING ORG. REPORT NUMBER
7. AUTHOR(s) J. C. Schulz O. E. R. Heimdahl S. Finnegan		8. CONTRACT OR GRANT NUMBER(s)
9. PERFORMING ORGANIZATION NAME AND ADDRESS Naval Weapons Center China Lake, California 93555		10. PROGRAM ELEMENT, PROJECT, TASK AREA & WORK UNIT NUMBERS AIRTASK A32-321C/008B/3F32-300- 000 Appropriation 1731319.41AJ

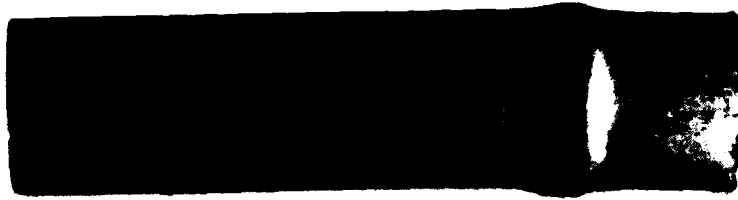
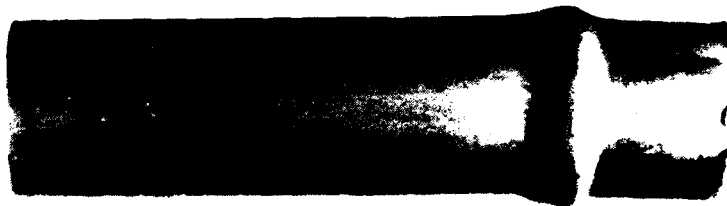
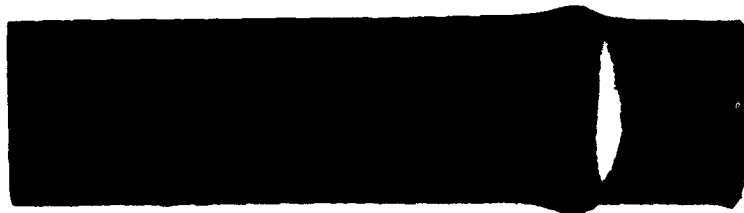
FIGURE B-1. Photographs of Unfilled Projectiles After Impact Against 0.5-Inch-Thick Slabs at 45 Degrees Obliquity.

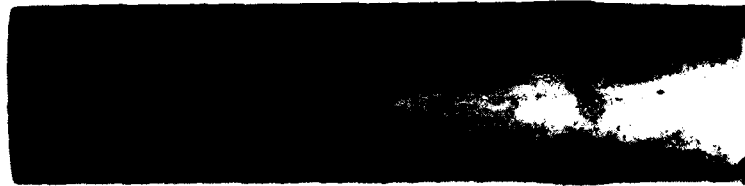
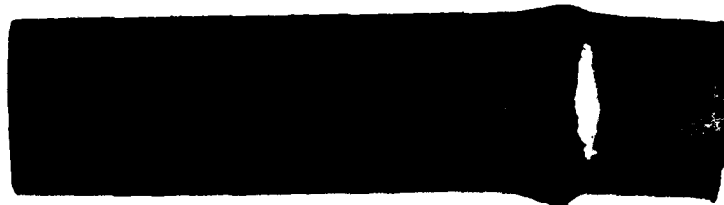
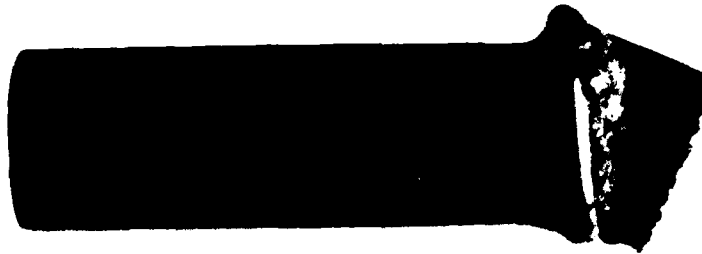
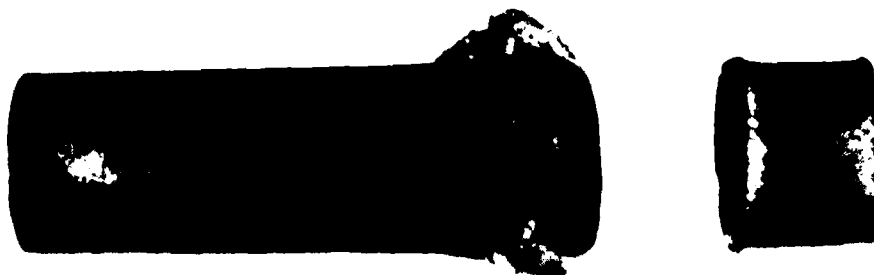
FIGURE B-2. Photographs of Unfilled Projectiles After Impact Against 1-Inch-Thick Slabs at 45 Degrees Obliquity.

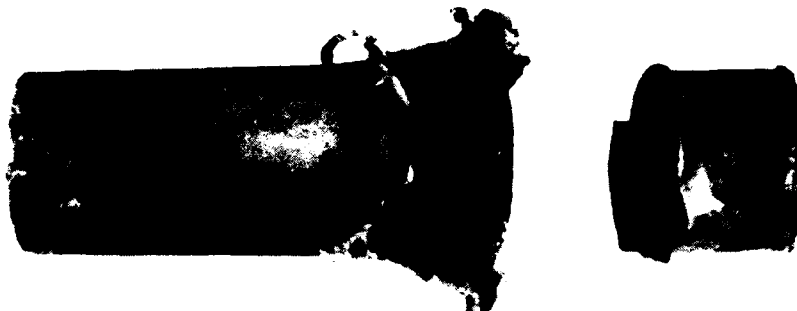
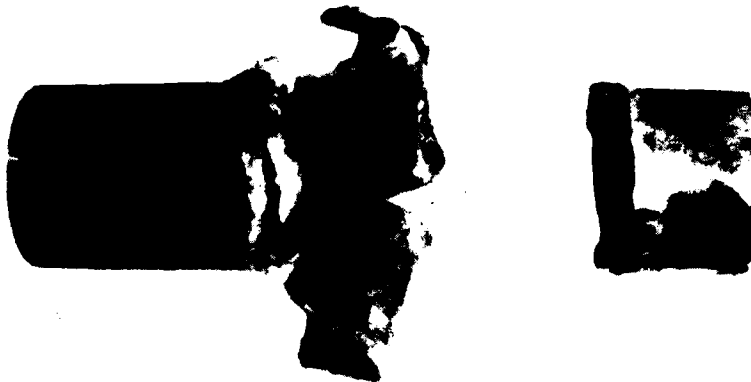
FIGURE B-3. Photographs of Unfilled Projectiles After Impact Against 2.5-Inch-Thick Slabs at 45 Degrees Obliquity.

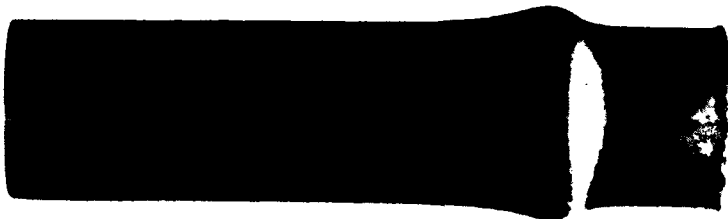
FIGURE B-4. Photographs of Unfilled Projectiles After Impact Against 0.5-Inch-Thick Slabs at 45 Degrees Obliquity.

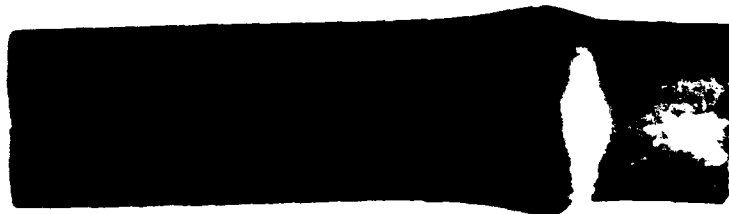
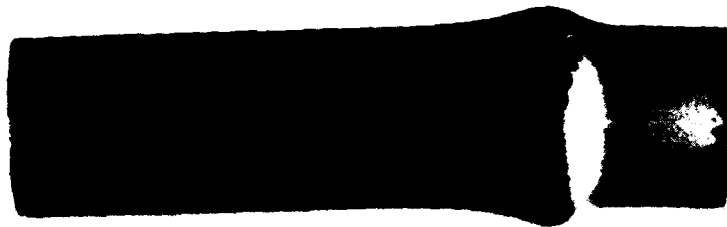
FIGURE B-5. Photographs of Filled Projectiles After Impact Against 1-Inch-Thick Slabs at 45 Degrees Obliquity.

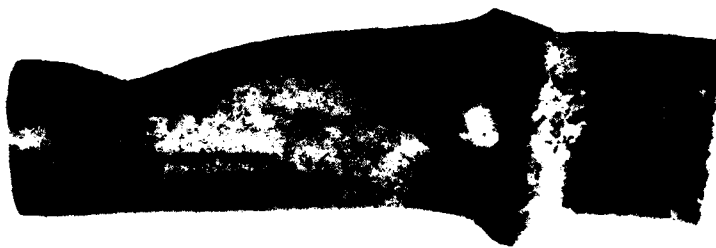
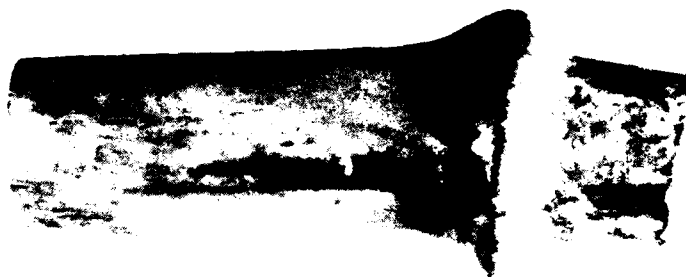
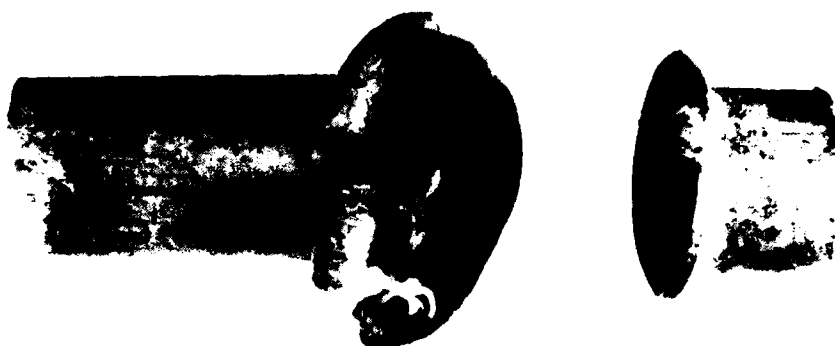
FIGURE B-6. Photographs of Filled Projectiles After Impact Against 2.5-Inch-Thick Slabs at 45 Degrees Obliquity.
